Jeans button injury: A unique type of injury and an occupational hazard

Jeans button injury is a highly uncommon injury caused by accidental punching of jeans button on the finger instead of denim cloth. This is a serious occupational hazard. This type of injury can be prevented by taking adequate safety precaution. The authors report a case of such injury and its appropriate management.

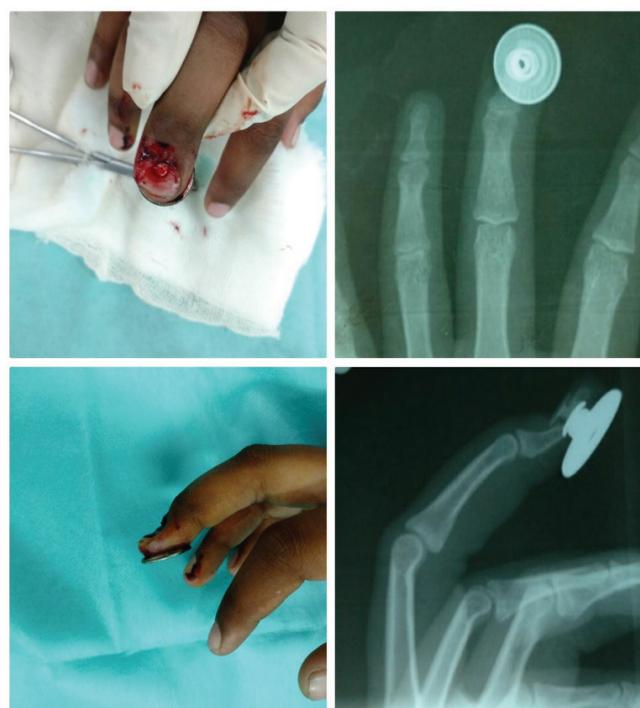
Figure 1. Clinical and radiological picture of the involved finger with jeans button *in situ*.

An 18-year-old male presented to the Emergency Department in our institution with a jeans button

punched on the tip of his right middle finger (Fig. 1). He complained of severe pain at the site of injury. Further enquiry revealed that his hand got stuck in the machine, which is used for punching jeans

button on denim. Examination of the finger showed the jeans button punched through the tip of the middle finger. The part of the tip of the finger distal to the jeans button was swollen, slightly white and painful, probably due to temporary disruption of vascular supply distally. Radiographs were taken to look for bony injuries (Fig. 1). The patient was immediately prepared for surgery and was taken to the operation theatre where jeans button removal was done under the axillary block. The details of the sequence of steps followed for removal of jeans button are being discussed now. First, the jeans button tack was removed. The round edges of the tack were everted using artery forceps. The tack was then detached from the jeans button by pulling it with a plier. Complete care was taken to avoid soft tissue crushing underneath the jeans button tack while detaching it from the jeans button. Then the jeans button was removed with the help of plier (Fig. 2). After the removal of the jeans button, X rays were taken to confirm complete removal of the Jeans button and to see the position of fracture fragments of the distal phalanx. The X rays in our case were suggestive of comminuted fracture of distal phalanx of the middle finger which was not significantly displaced and hence, it was decided to manage the fracture conservatively with buddy strap (Fig. 2). Dressing of the wound was done following wound lavage along with strapping. Healing of wound took place by secondary intention subsequently.

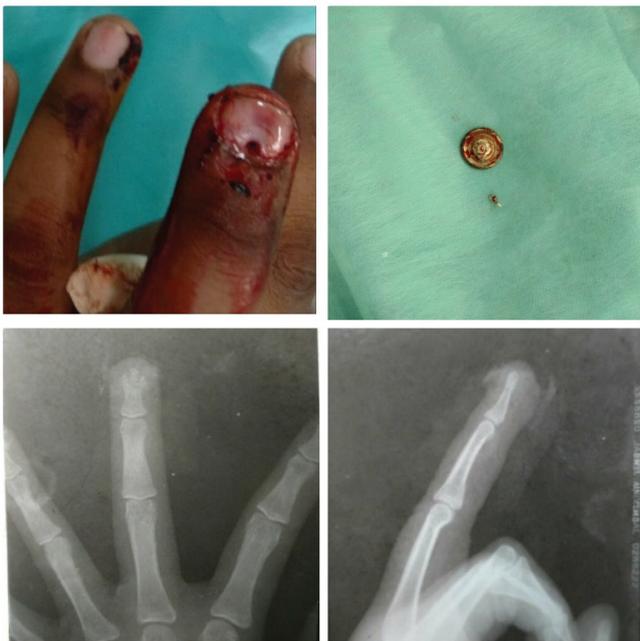
Figure 2. Clinical and radiological picture of the involved finger after removal of jeans button.

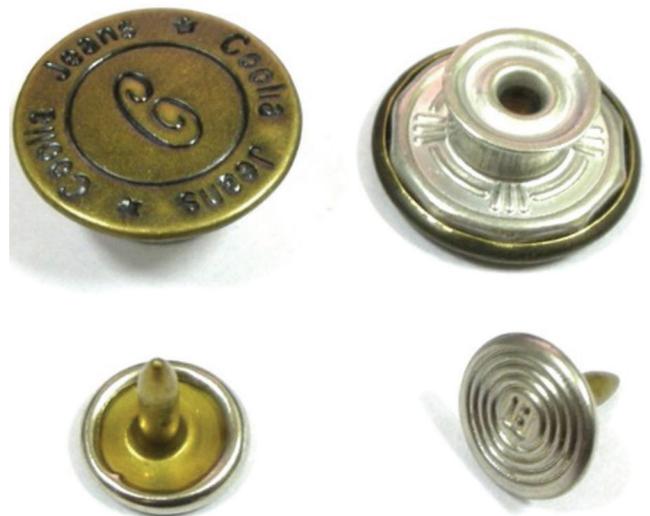
Figure 3. Jeans button and jeans button tack.

The jeans button is used as a method of fastening denim trouser. It is usually composed of two components, the jeans button and the jeans button tack (Fig. 3). In order to understand the mechanism of injury, we have to know how the jeans button is applied on denims. The jeans buttons are attached to the denim using automatic jeans button punching machines. There are two slots available in the machine. One is for jeans button and other is for jeans button tack. When the denim cloth is placed between the two slots, these slots press against each other resulting in the punching of a button on the denim. In our case, the finger got trapped between those slots resulting in the punching of jeans button on the finger. The authors also visited the factory to see how the machine works.
